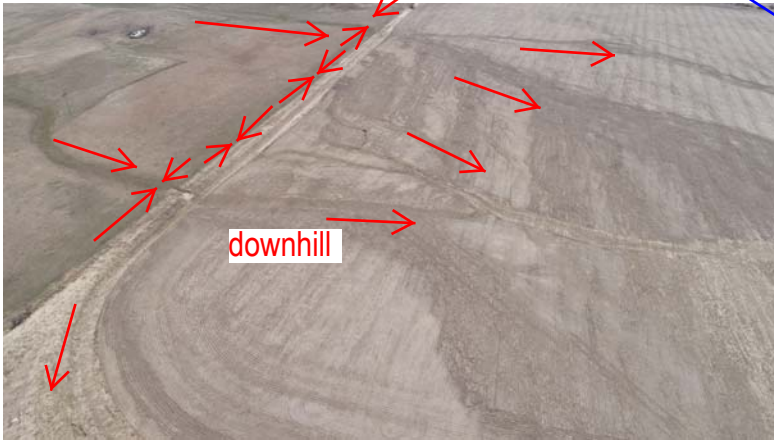
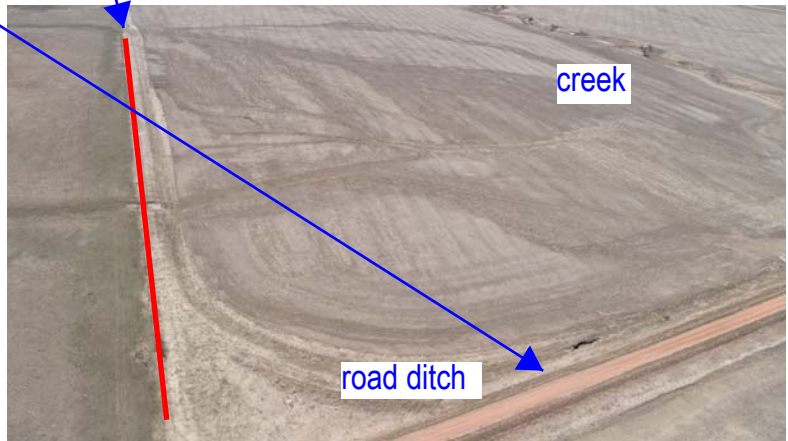
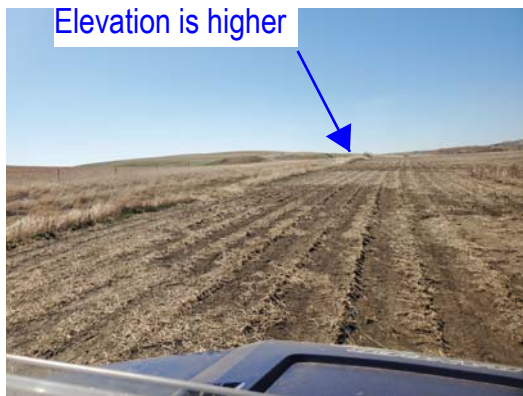
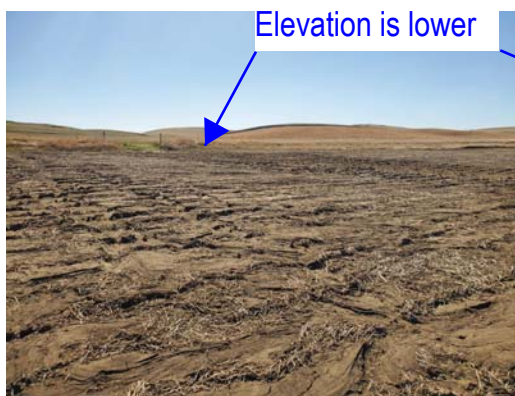
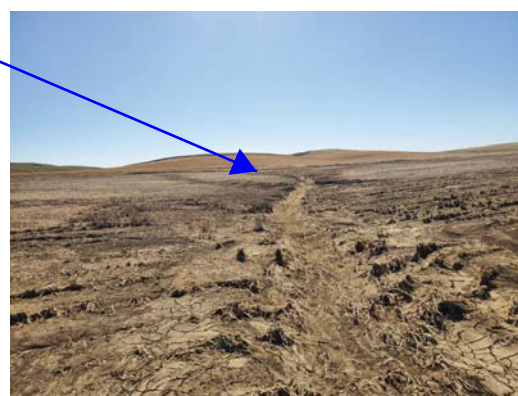
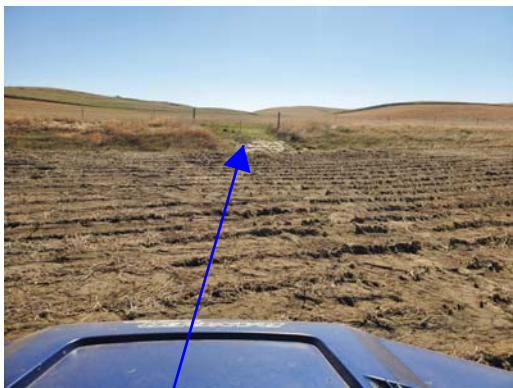
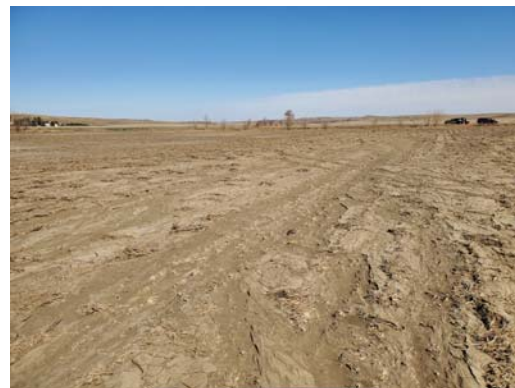
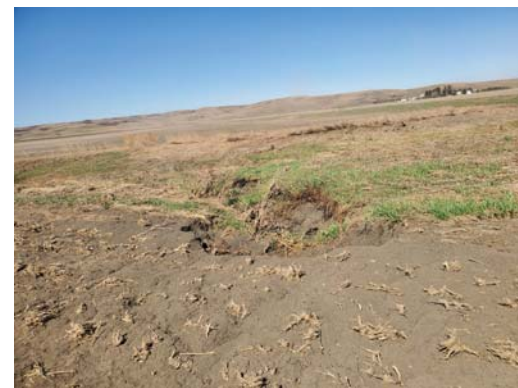
Water flows downhill inside the North American Coal (NAC) diversion ditch. When the diversion ditch is full, the water overflows the diversion ditch across the farmland and into the creek. This has resulted in significant erosion on the farmland.

Much of the water does "not" flow into the "road ditch".

The previous berm was removed by NAC. This provides a direct path from NAC land onto the farmland.

NAC should install a 3 foot wide, 3,500 psi, concrete berm next to the fence to direct all water into the road ditch. The concrete should contain multiple layers of rebar for the entire length to ensure the berm stays together as one piece.

The top of the berm should be 2 feet higher than the highest elevation of the farmland.

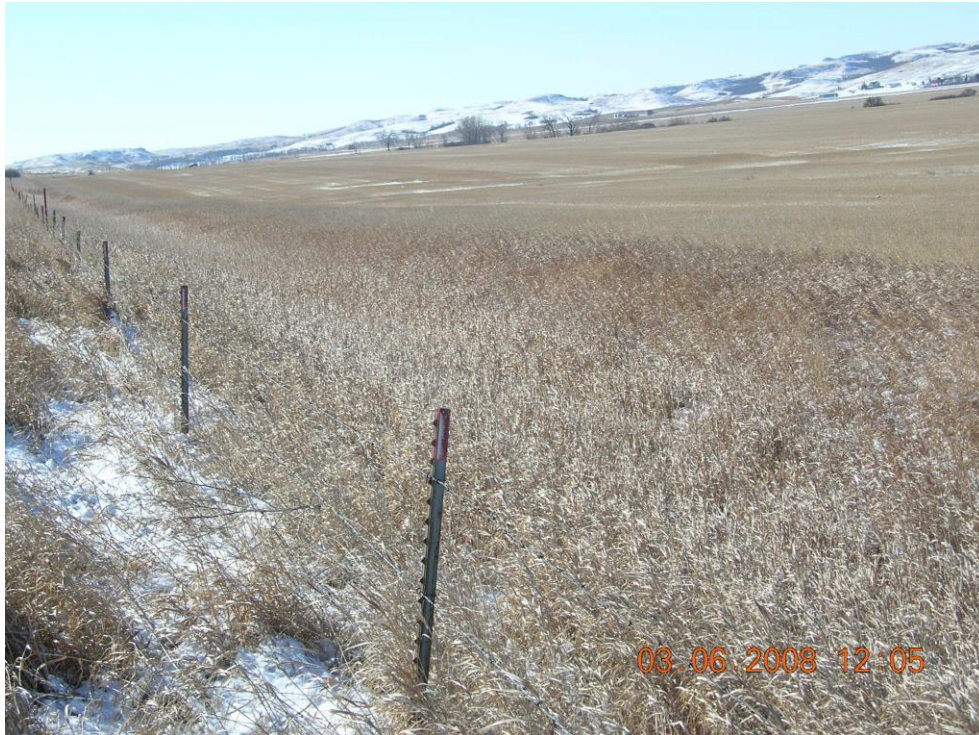
Prairie grass has deep roots up to 15 feet into the ground. Prairie grass deep roots help absorb water. The prairie grass, between the fence and field, was removed by NAC.

Original prairie grass between fence and field.

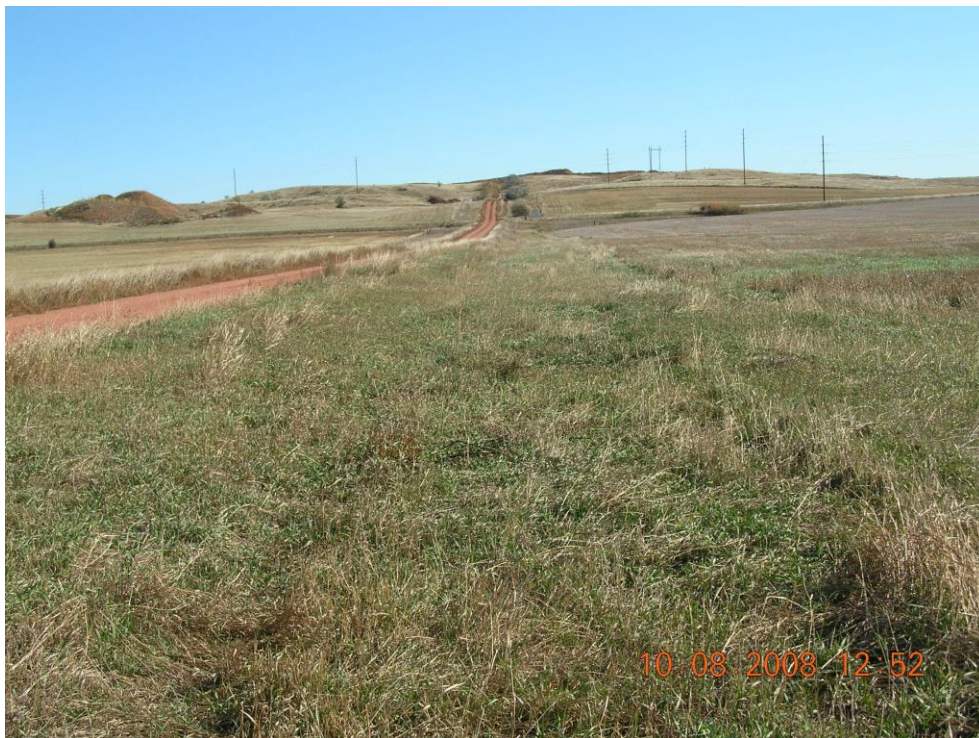
Original road ditch. Easy for a grain truck to cross onto the field.

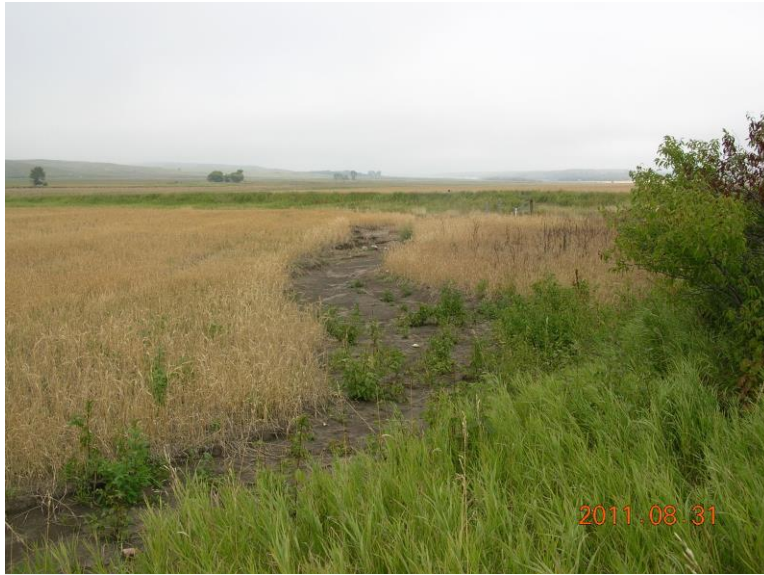
North American Coal Pond Water Overflow in 2011.

NAC should be
required to pay the
landowners \$10,000
when a Pond
overflows.

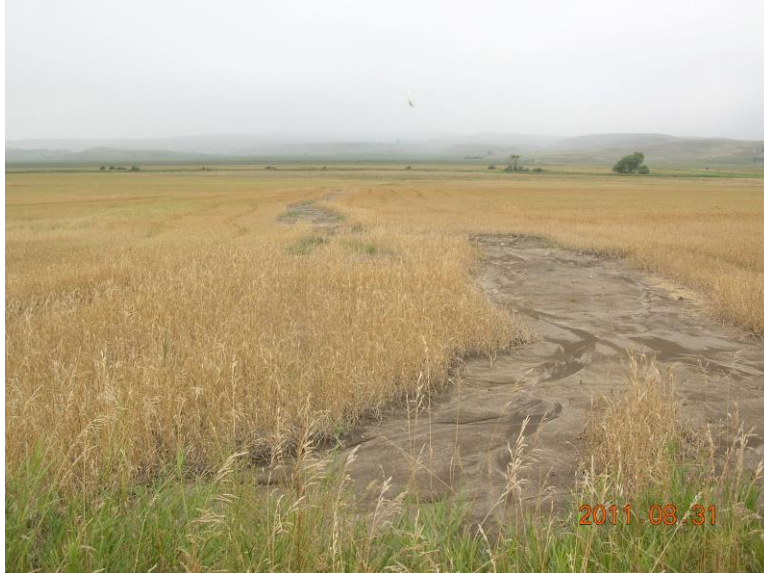
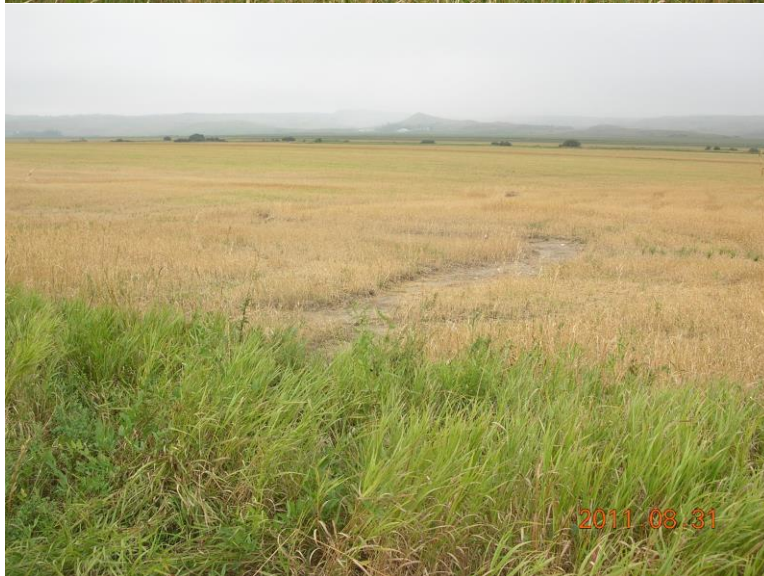
North American Coal Pond Water Overflow in 2014.

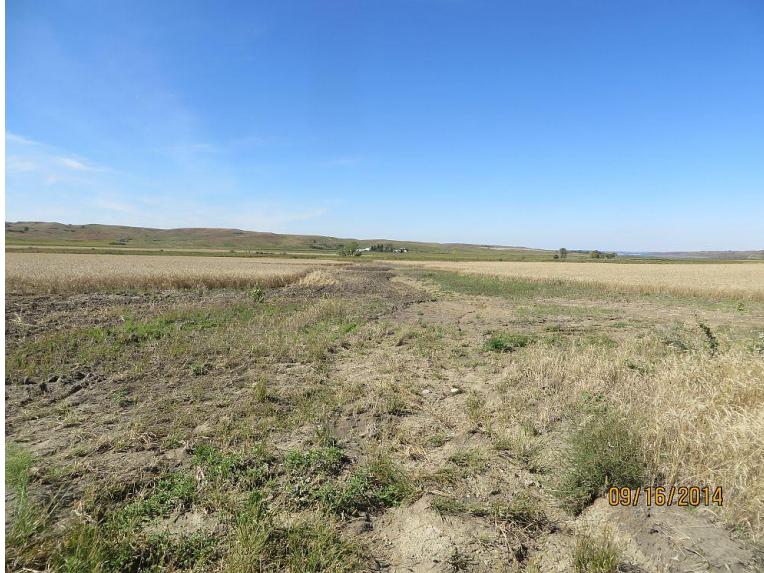
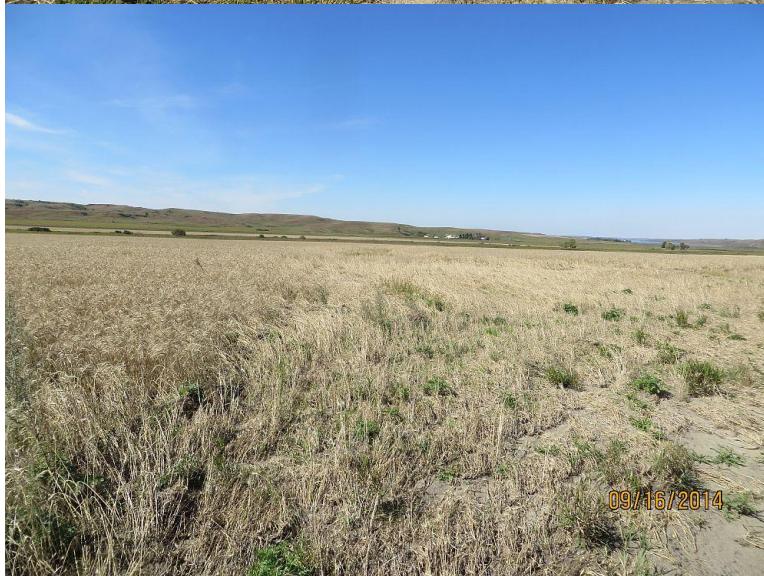
A PSC Inspector
found pond water
netting on the
farmland.

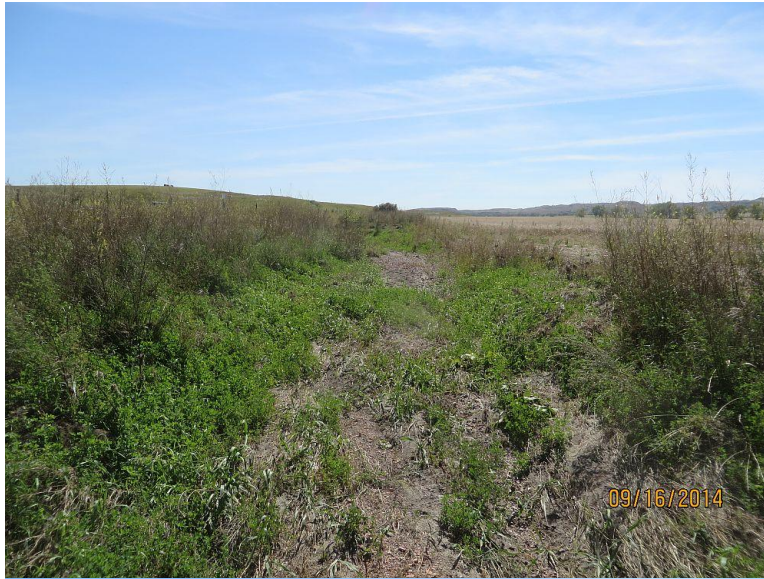
2014

North American Coal
Deep / Wide Diversion Ditch

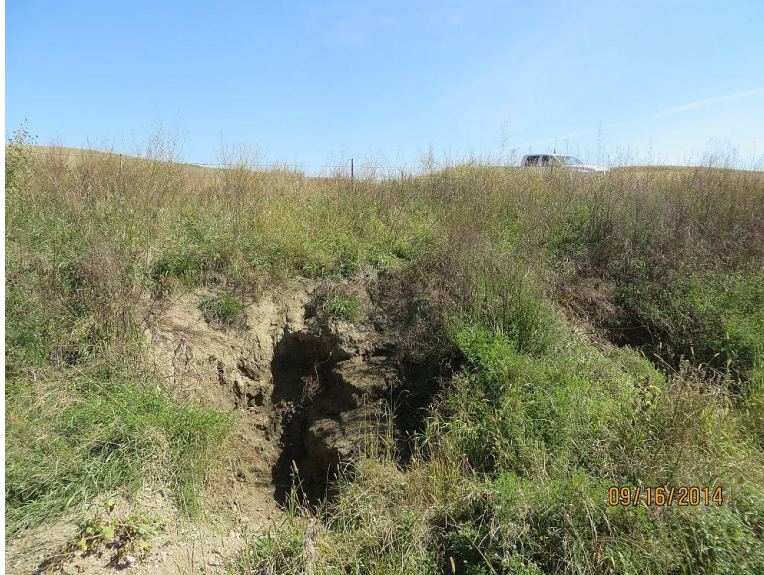
2014

The NAC diversion ditch was dug on Esther Eisenbeis' farmland without proper authorization.

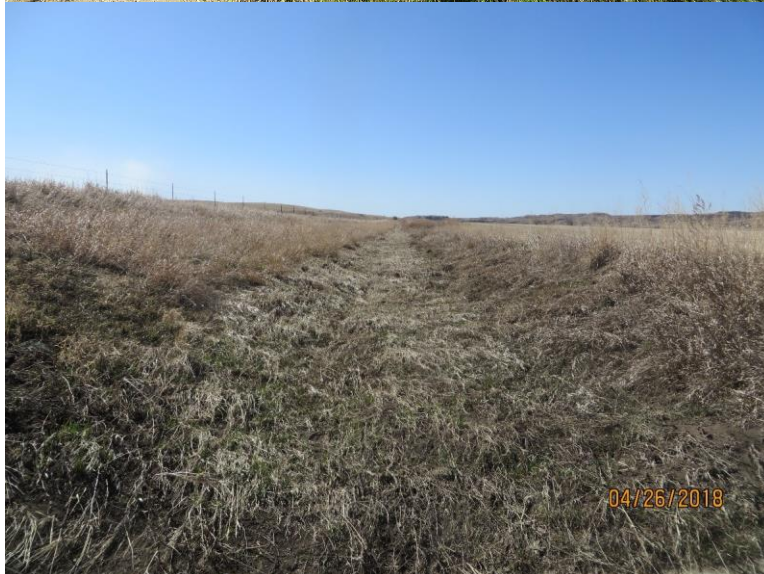
2018

The original prairie grass was removed by NAC.

.
Prairie grass has deep roots up to 15 feet into the ground.

.
Prairie grass deep roots help absorb water.

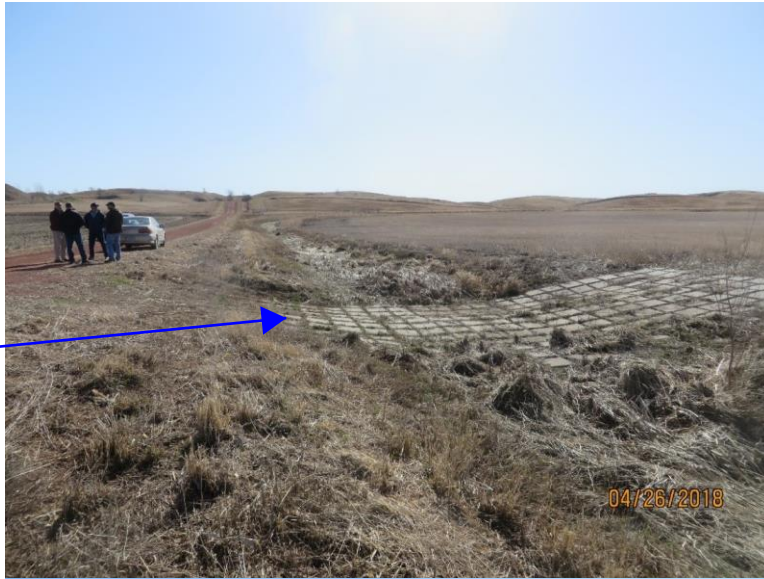
2018

North American Coal (NAC)
Deep / Wide Road Ditch

NAC did not obtain a Mercer County permit to dig the road ditch deeper.

This is not an approach. A truck loaded with grain would tip over.

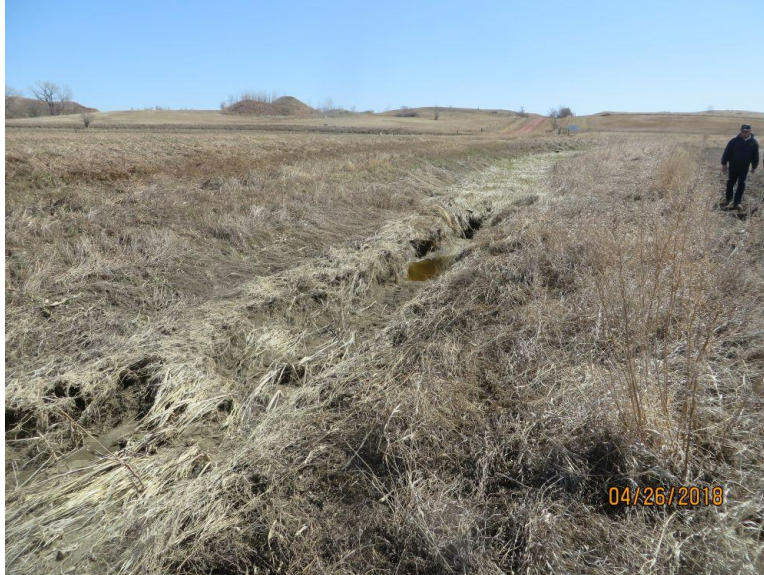
2018

NAC agreed to install an approach in 2016. The farmland renters were at that meeting by the farmland.

NAC reneged after NAC was not allowed to discharge more water into the creek.

The road ditch begins to erode.

NAC should install an approach large enough to accommodate a semi-grain truck.

The approach should have two large culverts in parallel to ensure water does not flow onto the farmland.

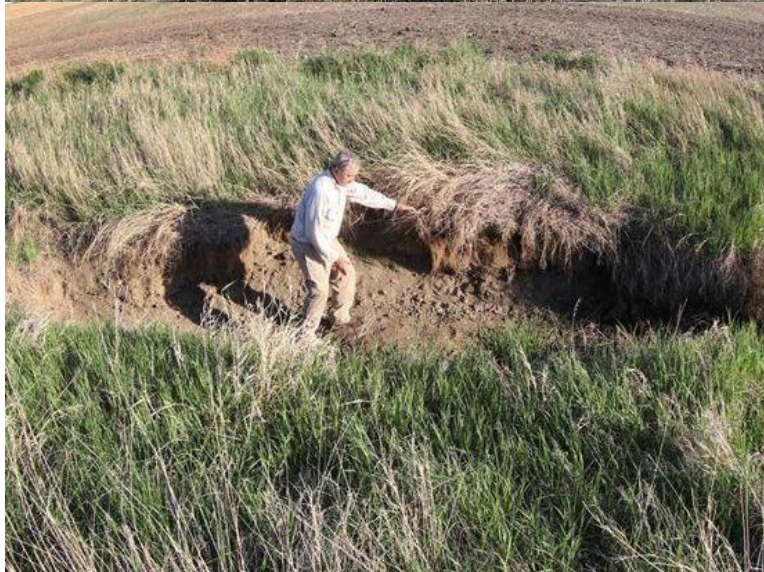
2022.

The road ditch continues to erode.

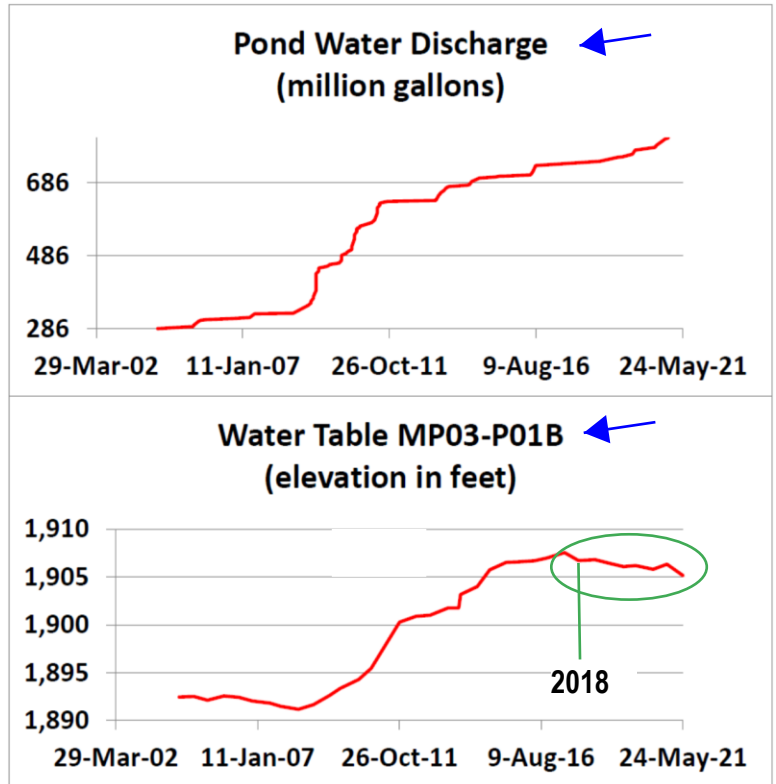
May 2021 Pond Water Discharge into Farmland Creek

Pond water discharge raised the elevation of the water table. Eventually the water table elevation reached the farmland elevation. The southwest corner of the farmland was flooded.

As the SW corner of the farmland was flooded for many years, the quality of the soil has deteriorate. The crop yield in that area is now less than 10 bushels per acre.

NAC claims that extra rain caused the water table elevation to increase. NAC does not disclose is that extra rain required more water discharge from the pond into the creek which raised the water table.

NAC should be required to discharge pond water via pipe directly into Lake Sakakawea to guarantee the pond water does not raise the water table elevation.

NAC should also be required to place a plastic liner under every pond to ensure none of the water flows into the ground, which could raise water tables.
